Flooding at Letterkenny General Hospital

Stage 2 Engineering Assessment

September 2013

TOBIN CONSULTING ENGINEERS

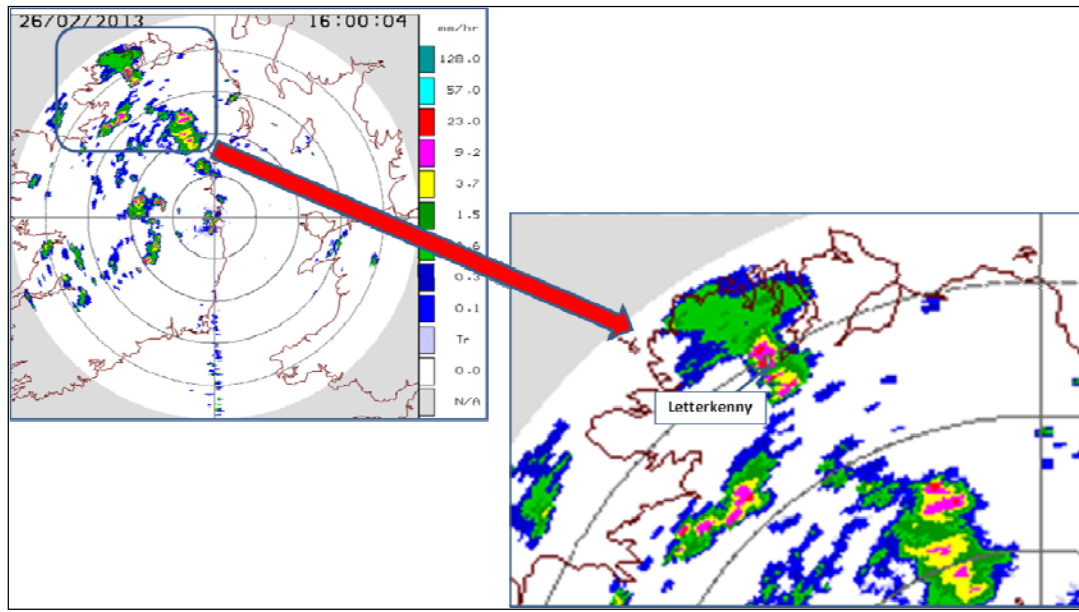
Figure 1: Met Eireann Rainfall Radar Image, 1700hrs BST (1600hrs GMT), Friday 26th July 2013

Looking at the radar image, it can be deduced that at 1700hrs (BST/local time), rainfall intensity exceeded 57mm/hr in an area local to the catchment of the Sprackburn Tributary. Based on verbal accounts of the event and on CCTV footage at the hospital it appears that the intense rainfall event lasted between 15 and 25 minutes. Following preliminary discussions with Met Eireann, this rainfall intensity and duration can be considered to be somewhere between a 1 in 20 year and a 1 in 25 year event.

We would however caution against drawing any definitive conclusions from this assessment of return period based on rainfall radar data, as the reliability of the assessment is low, given that the rainfall intensity data is taken from a radar based over 200km away and there are a number of topographical and other interferences that reduce the accuracy of the data.

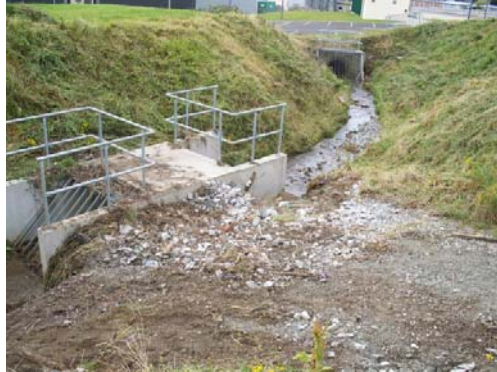
Figure 2: Screens and Culvert Entrance (photo taken 30th July 2013)

The Sprackburn Tributary enters a 1350mm diameter culvert to the north of the hospital buildings, as shown in Figure 2. The culvert is protected by two screens, a primary screen (left hand side of the photo) sitting in the stream approximately 15m upstream of a secondary screen at the entrance to the culvert itself (back right of the photo). These screens were installed to:

During the rainfall event on the evening of 26th July these screens became blocked with debris washed down from the upper catchment, leading to a situation where water could not enter the culvert and an overflow occurred, overtopping the culvert headwall and flooding the hospital car park and property.

As part of the response to the emergency during the overflow, hospital staff removed debris from the two screens to alleviate the flooding. Based on accounts from the personnel who removed the material and from our inspection of material taken from the screens (which was still on site), the debris consisted of a wide range of material, including tree branches (large and small), domestic rubbish, tyres and other items including barbecues, gas cylinders and large items of plastic. The presence of such loose material in or adjacent to the stream or capable of being washed into the stream by heavy overland flows was a major contributory factor to the flood event.

Given that the on 26th July 2013 a significant amount of debris from the Sprackburn Tributary catchment arrived at the screen protecting the culvert entrance, and that the blockage of the screen caused by this debris was the most likely cause of the flooding of the hospital, it is prudent to review the design of these existing screens and consider alternative screening arrangements that would reduce the risk of a recurrence of similar screen blockage. Consequently, we are currently carrying out such a review against various guidance documents for trash and security screens, including UK Environment Agency's Trash and Security Screen Guide, 2009.

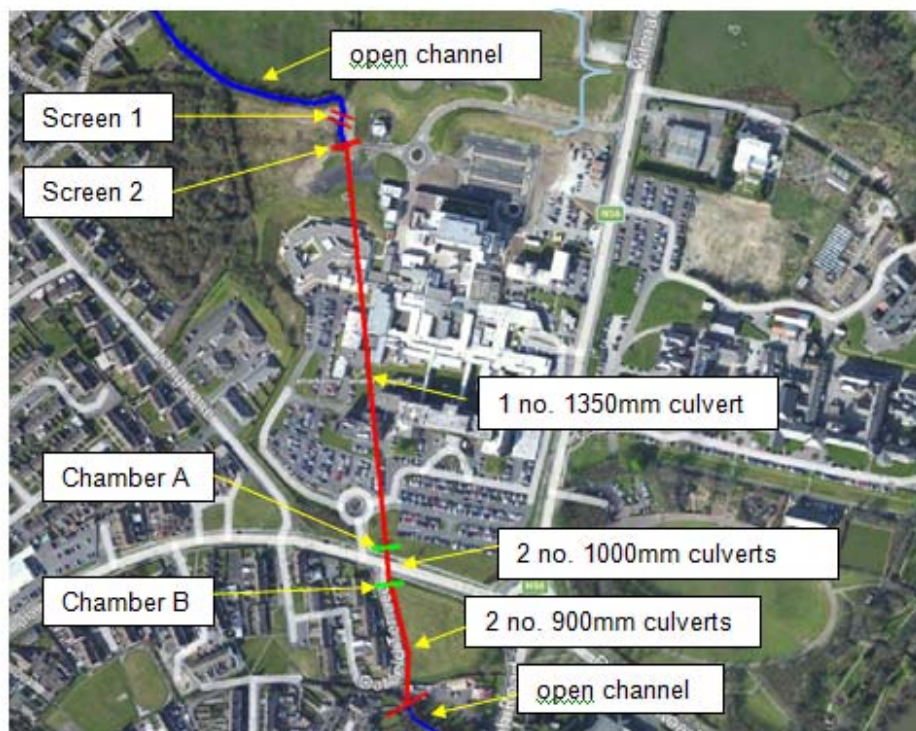
Figure 2 Layout of the Channel/Culvert in the Vicinity of Letterkenny Hospital

Figure 2 shows the approximate route of the culverted section of the Sprackburn Tributary which traverses the hospital grounds. The culvert consists of three distinct sections.

- Section 1; 1350mm diameter concrete culvert passing underneath the hospital, 324 metres long to an underground chamber (Chamber A).
- Section 2; twin 1000mm diameter concrete pipes, 27 metres long passing under Circular Road to a second underground chamber (Chamber B)
- Section 3; twin 900mm diameter concrete pipes, 96 metres long, running parallel to Oatfield Terrace and discharging back into an open channel

- *Section 1*: 1350mm single pipe, 324m long, entry invert level 62.20mOD, exit invert level 50.12mOD, average gradient 1 in 27.
- *Section 2*: twin 1000 pipes, 27m long, entry invert level 50.12mOD, exit invert level 49.17mOD, average gradient 1 in 28.
- *Section 3*: twin 900mm pipes, 96m long, entry invert level 49.17mOD, exit invert level 45.85mOD, average gradient 1 in 29.

The result of this assessment indicate that, assuming water is not prevented from entering the culvert from, for example, blockages at the protective screens, the existing 1350mm culvert has a capacity of the order of 7m³/s.
