# **Flooding at Letterkenny General Hospital**

# **Review of Screen Design**

November 2013

# TOBIN CONSULTING ENGINEERS

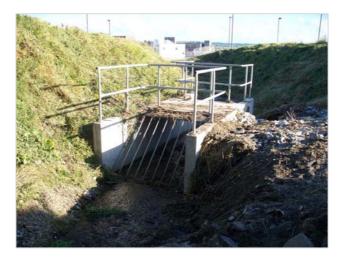
Figure 1: Upstream Trash Screen

Using the accepted terminology, the upstream screen operates as a coarse <u>trash screen</u>, while the downstream screen primarily operates as a <u>security screen</u> (but also collects trash under certain flood conditions).

The bar spacing of 200mm on the upstream trash screen complies with this requirement.

- The existing upstream screen will be demolished and replaced by Screen 2A which will be constructed approx. 15m upstream of the culvert entrance, and will also consist of two stepped screens as shown on Drawing 7284-2014. This screen will have a bar spacing of 200mm in accordance with Section 8.4 of the Security and Trash Screen Guide and will screen debris on the both the Sprackburn Tributary and Northern Tributary. The screen angle will be set at 60° to the horizontal.

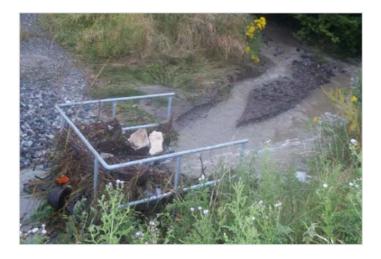
If the downstream screen was primarily designed as a security screen, then in theory very little debris should have arrived at it, given the presence of a trash screen 20m upstream. However the downstream screen obviously <u>did</u> block on 26<sup>th</sup> July 2013, as the upstream screen was overwhelmed by the amount of debris arriving at it, part of which transferred to the downstream screen. The photograph below shows the substantial quantity of debris captured by the upstream screen. The screen was completely overwhelmed and in all likelihood a substantial quantity of debris bypassed this screen and made its way to the downstream screen.

Figure 3: Upstream Trash Screen after the Flood
